Test Report

Bearing-Hole Tests for 20” Pole Sections of Fiberglass-Reinforced Composite Poles: Effect of Torque

POWERTRUSION
INTERNATIONAL, Inc.

July 2002

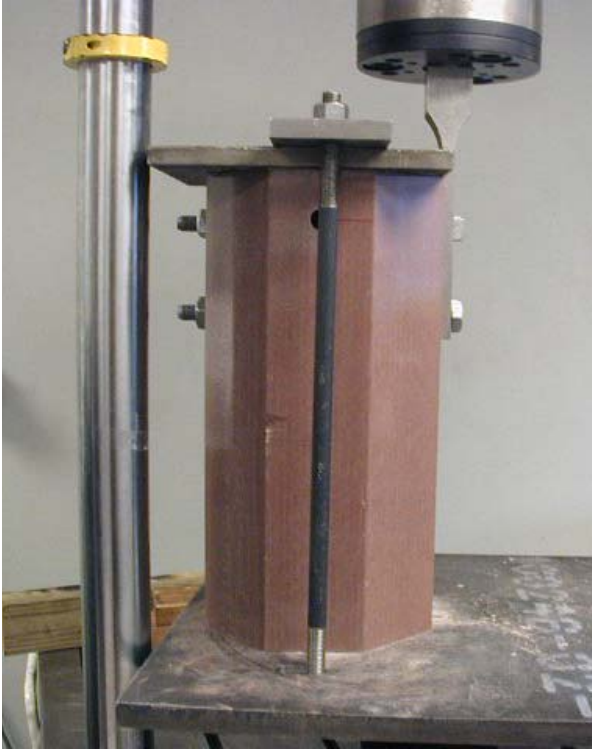
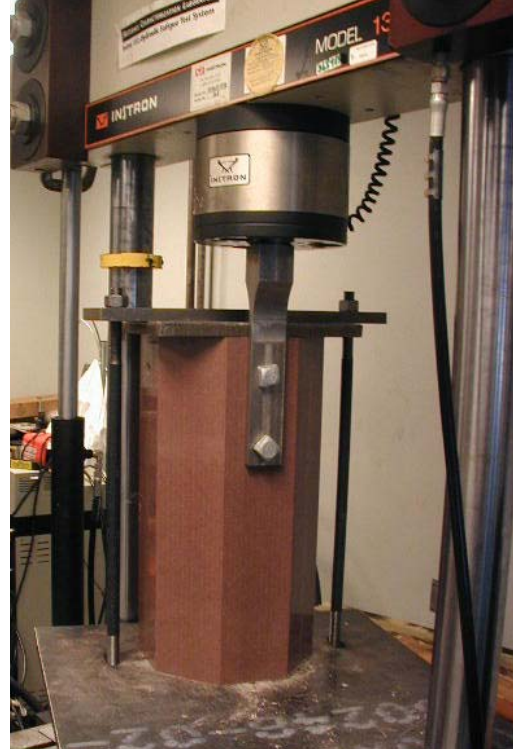
The test method is identical to ASTM D 953 and is summarized here. A calibrated Instron test frame is used with a displacement rate of 0.05 in/min. A loading fixture of hardened steel is used and is shown in the Figure below. Each specimen is mounted in the loading fixture taking care to align the loading face of the specimen with the centerline of the test fixture. The specimen is then through bolted using the bolt hardware provided and lightly torqued (maximum of 10 ft-lbs). The specimen was loaded at 0.05 in/min of crosshead travel and load and displacement documented till specimen failure.

Test Setup for Bearing Hole Tests
